EP 1 286 020 A2

(54) **Method for repairing an apertured gas turbine component**

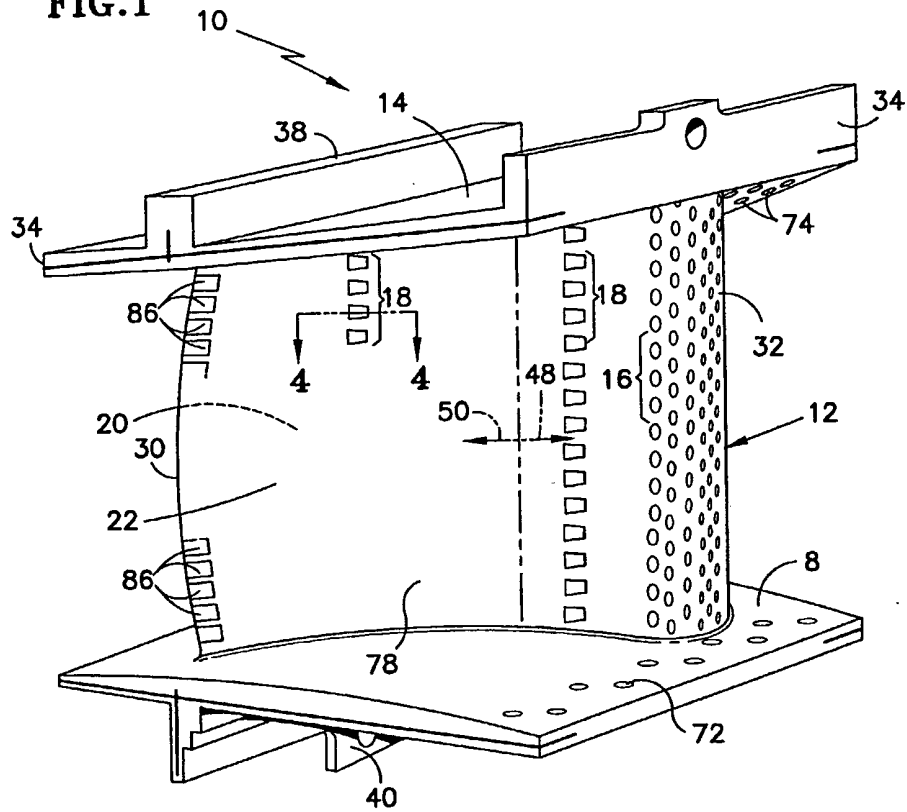
FIG.1

Fig. 1 is a perspective view of a typical gas turbine engine high pressure turbine vane;

[0025] Referring to Fig. 1, a high pressure turbine vane (article) 10 is shown. Referring also to Figs. 2 and 3, a top view and a bottom view are respectively shown for the vane 10 of Fig. 1. The vane 10 comprises an airfoil section (airfoil) 12 having at least one internal cavity 24 (Fig. 2), the internal cavity 24 having an internal surface 26 (Fig. 2). The airfoil section 12 has a convex surface 20 and a concave surface 22. The convex and concave surfaces 20, 22, respectively, are bounded by a trailing edge 30 and a leading edge 32 and together form an exterior surface 78 of the airfoil. The exterior surface 78 is exposed to the hot gas path. The trailing edge 30 of the airfoil 12 includes cooling slots 86. Also, the airfoil section 12 is bounded by an inner diameter platform (platform) 8 and an outer diameter platform (platform) 14. The inner and outer diameter platforms 8, 14 create the gas path annulus and include cooling holes 72, 74, respectively. The outer diameter platform 14 includes opposing flanges 34, at least one cover 36 (Fig. 2), preferably two, and a rail 38. The inner diameter platform 8 includes a rail 40 and a cover 42 (Fig. 3), preferably two.

[0027] The vane 10 lies in the hot gas path and the vane 10 is air-cooled by flowing cooling air, typically from the compressor discharge, into the internal cavities 24. Cooling air enters the internal cavities 24 through corresponding openings in the platforms 8, 14. This air cools the internal surface 26 of the airfoil 12 by convection or internal baffle impingement and cools the convex and concave surfaces 20, 22, respectively, of the airfoil 12 by film cooling. The air is directed from the internal cavities 24 and outward across the vane 10 by a plurality of cooling holes, preferably cylindrical cooling holes 16 and diffusion cooling holes (diffusion holes) 18, to help it withstand the high temperatures to which it is exposed. The cooling air is also directed across the platforms 8, 14 upon exiting the respective cooling holes 72, 74. The trailing edge 30 is cooled by air exiting through the slots 86.

[0028] Although Fig. 1 shows the plurality of cooling holes 16, 18 located on the concave surface 22, it is readily understood by those skilled in the art that the plurality of cooling holes 16, 18 are formed on both the convex and concave surfaces 20, 22, respectively.

[0031] Referring now to Figs. 1 and 4, it is noted that the vane 10 has a plurality of diffusion holes 18 which may have various geometries and predetermined air flow characteristics based on location within the vane 10. The representative diffusion hole 18, shown in Fig. 4, has a metering passage 60 in fluid communication with a diffusion passage (mouth) 52, each having a predetermined geometry. The metering passage 60 has an inlet 76 with a predetermined throat area, shown as A_t , where the throat area A_t provides a predetermined air flow requirement. Thus, the inlet 76 regulates cooling air flow into the diffusion holes 18 from the internal cavities 24. The diffusion passage 52 is axially diverging, nonregulatory and extends from the inlet 76 to an outlet 77 at the exterior surface 78 of the vane 10. The diffusion passage 52 facilitates the film cooling of the exterior surface 78 of the airfoil 12 as the cooling air exits from the diffusion passage 52 of the diffusion hole 18. The diffusion passage 52 also includes an inner shaped portion (inner diffuser portion) 80 while the metering passage 60 includes an inner metering portion 82.

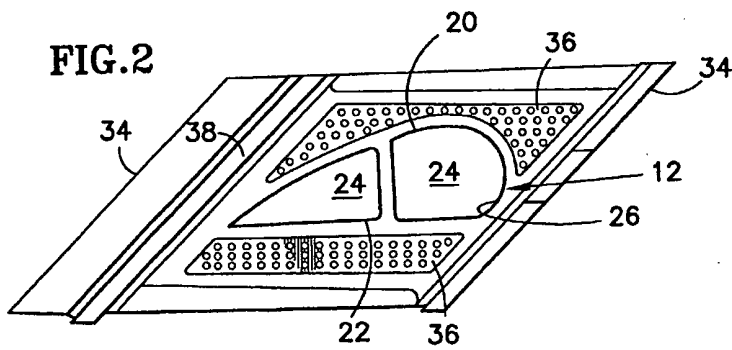
FIG.2

Fig. 2 is a top view of the vane of Fig. 1;

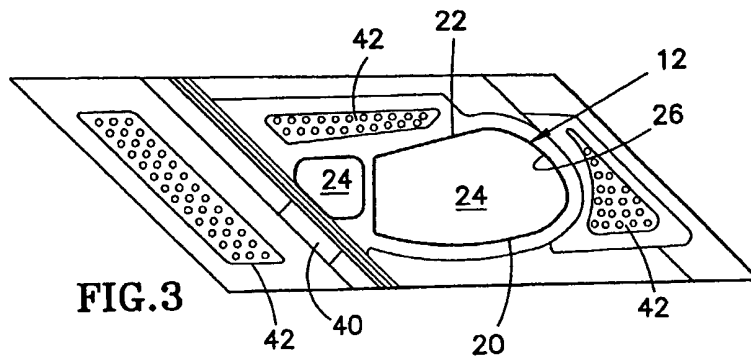
FIG.3

Fig. 3 is a bottom view of the vane of Fig. 1;

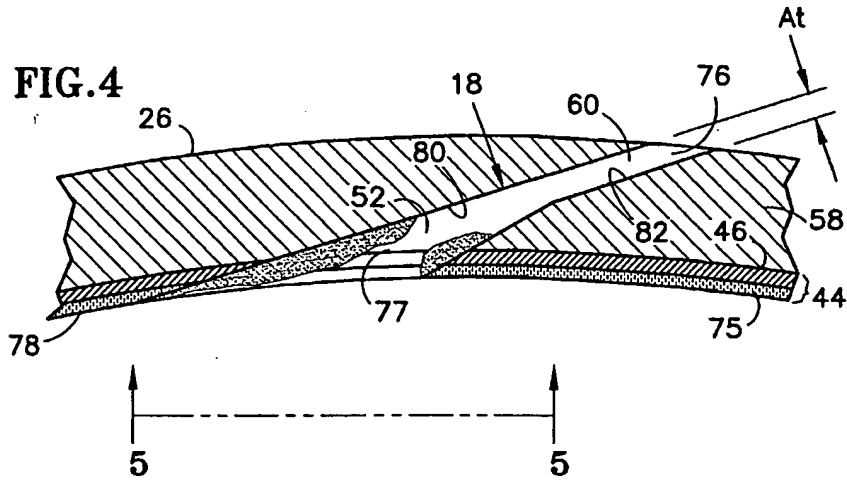
FIG.4

Fig. 4 is an enlarged cross-sectional view taken essentially in the direction 4-4 of Fig. 1 and illustrating the vane substrate, an existing protective coating applied to the substrate and a typical diffusion cooling hole extending through the substrate and the coating;

[0029] Referring to Fig. 4, a cross-sectional view of the wall thickness of the airfoil 12, and in particular the diffusion hole 18, is shown taken along the line 4-4 of

[0048] Referring now to Figs. 1, 4 and 5, diffusion holes 18 located in region 50 may require reworking. The application of the nonoriginal metallic bond coat 46 to the entire surface 78 of the vane 10 may result in a quantity of excess bond coating accumulating in the diffusion passage 52 of the diffusion holes 18 thus reducing the area through which the cooling air passes. Since this "coatdown" phenomena, as shown in Figs. 4 and 5, affects most, if not all of the diffusion holes 18 in region 50, the effectiveness of the cooling medium is diminished and the vane's durability is compromised. The coatdown phenomenon is normally not a problem during the manufacture of original equipment vanes since the protective coatings, and in particular, the metallic bond coat, are usually applied prior to installation of the cooling holes.

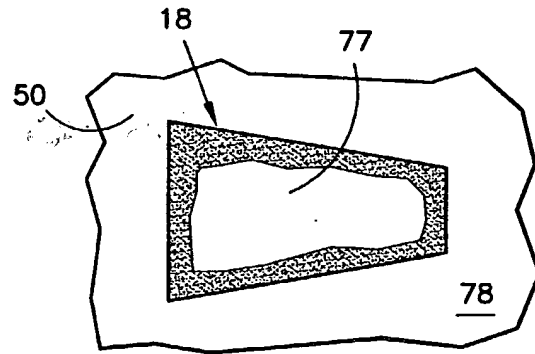
FIG.5

Fig. 5 is a view taken essentially in the direction 5-5 of Fig. 4 showing the diffusion hole prior to the repair of the present invention;

Fig. 1. Fig. 5 shows a view taken essentially in the direction 5-5 of Fig. 4 showing the diffusion hole 18 prior to the repair of the present invention.

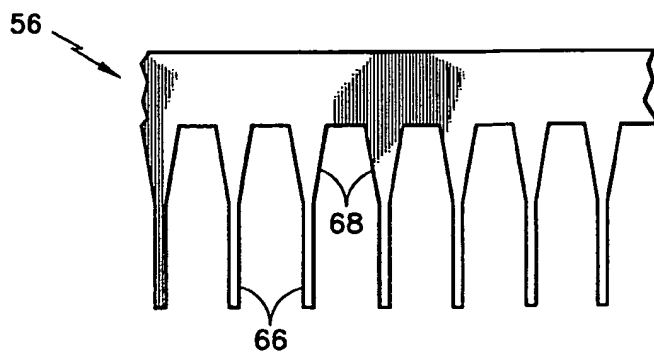
FIG.6

Fig. 6 is a side view of an electrode suitable for use with the repair method of the present invention; and

[0051] Referring to Figs. 6 and 7, electrodes 56, 62 suitable for insertion into an electric discharge machining device are shown. Referring to Figs. 1, 4, 5 and 6, the remanufacture and repair of the diffusion holes 18 in local regions 48, 50 of vane 10 using electrodes 56, 62, respectively, will now be described.

[0052] The electrode 56 includes a metering portion 66 and a diffuser portion 68. The electrode 62 includes a diffuser portion 70. It is noted that the geometry of the individual electrodes 56, 62, specifically the respective portions 66, 68, 70, are preselected to correspond to the required shape of the corresponding diffusion hole 18 to which it is used. In particular, the electrode 56 is chosen to restore the inner diffuser portion 80 and inner me-

[0054] In local region 48, the diffusion hole 18 is now remanufactured using the electrode 56. Since the repair material filled the diffusion hole 18, both the metering portion 66 and diffuser portion 68 of the electrode 56 are required to effect the remanufacture. The diffuser portion 68 of the electrode 56 corresponds in shape to the diffuser passage 52, and more specifically, the inner diffuser portion 80, of the diffusion hole 18. While, the metering portion 66 of the electrode 56 corresponds to the metering passage 60, and more specifically, the inner metering portion 82 of the diffusion hole 18.

[0055] However, in local region 50, the diffusion holes 18 may be partially or fully clogged, as described earlier, and therefore will need to be reworked to restore the cooling effectiveness of the diffusion hole 18 as well as vane durability. This is accomplished by using the electrode 62 to remove the excessive bond coat material. The electrode 62 may be easily formed by removing a metering portion from an electrode that has a diffuser portion corresponding in shape to the diffuser passage 52, and more specifically, the inner diffuser portion 80, of the diffusion hole 18. This can be accomplished by using a cutting means, for example scissors, to remove the metering portion.
